SI-20A

LOW PASSIVE INTERMODULATION TERMINATION

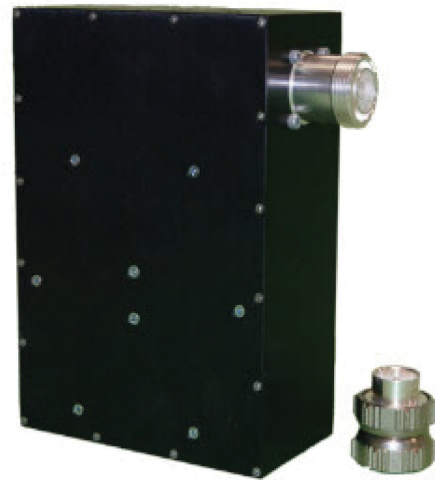
The SI-20A provides a means of terminating cables and test ports without generating significant levels of intermodulation products.
